**FINAL SITE MANAGEMENT PLAN FISCAL YEARS 2008 THROUGH 2012  
PETROLEUM, OIL AND LUBICANT SITES NAS OCEANA VA**

# **Site Management Plan Fiscal Year 2008-2012**

## **Petroleum, Oil, and Lubricant Sites**

**December 2008**

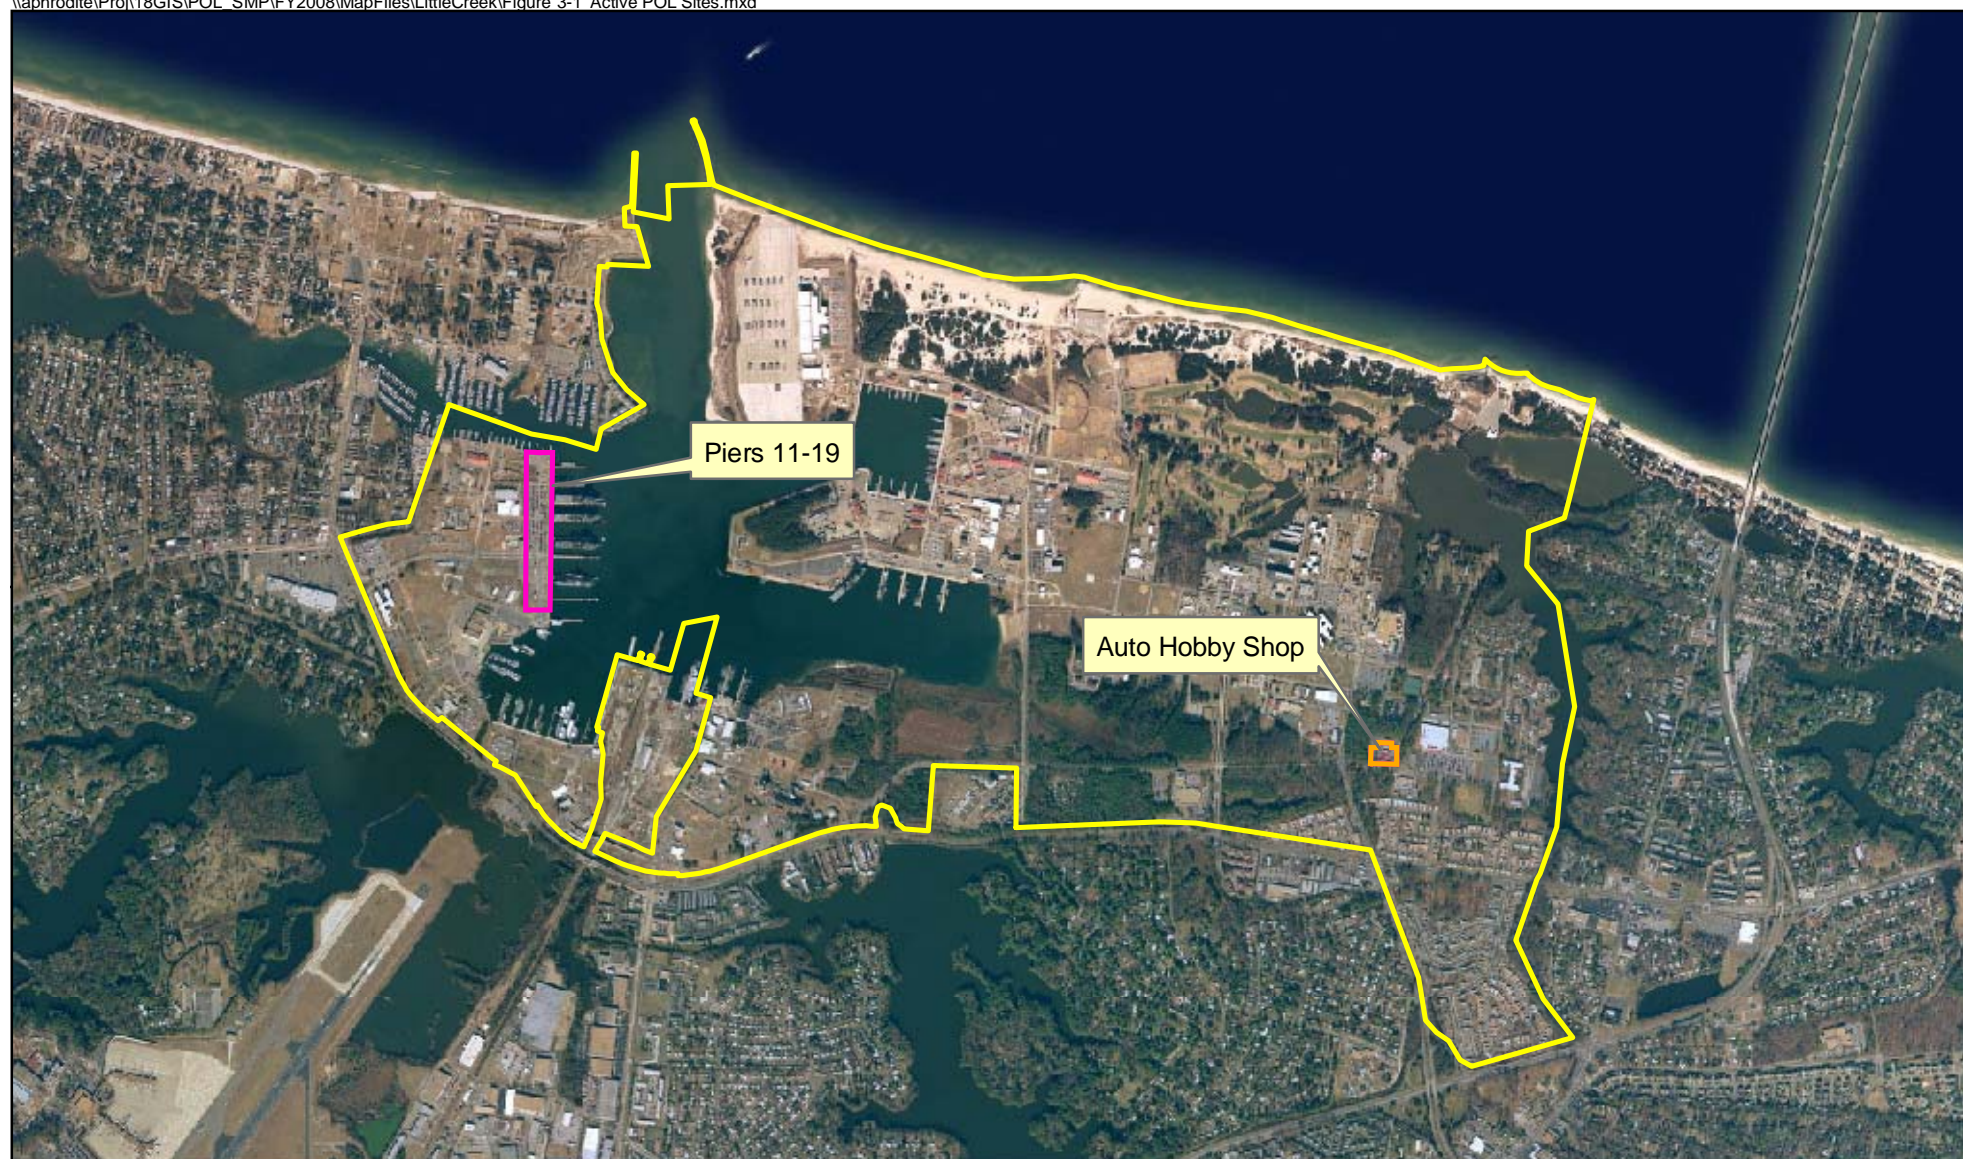
Figure 3-1  
Active POL Sites  
NAB Little Creek  
Virginia Beach, VA

- Active POL Sites
- Recently Closed POL Site (August 2008)
- Facility Boundary

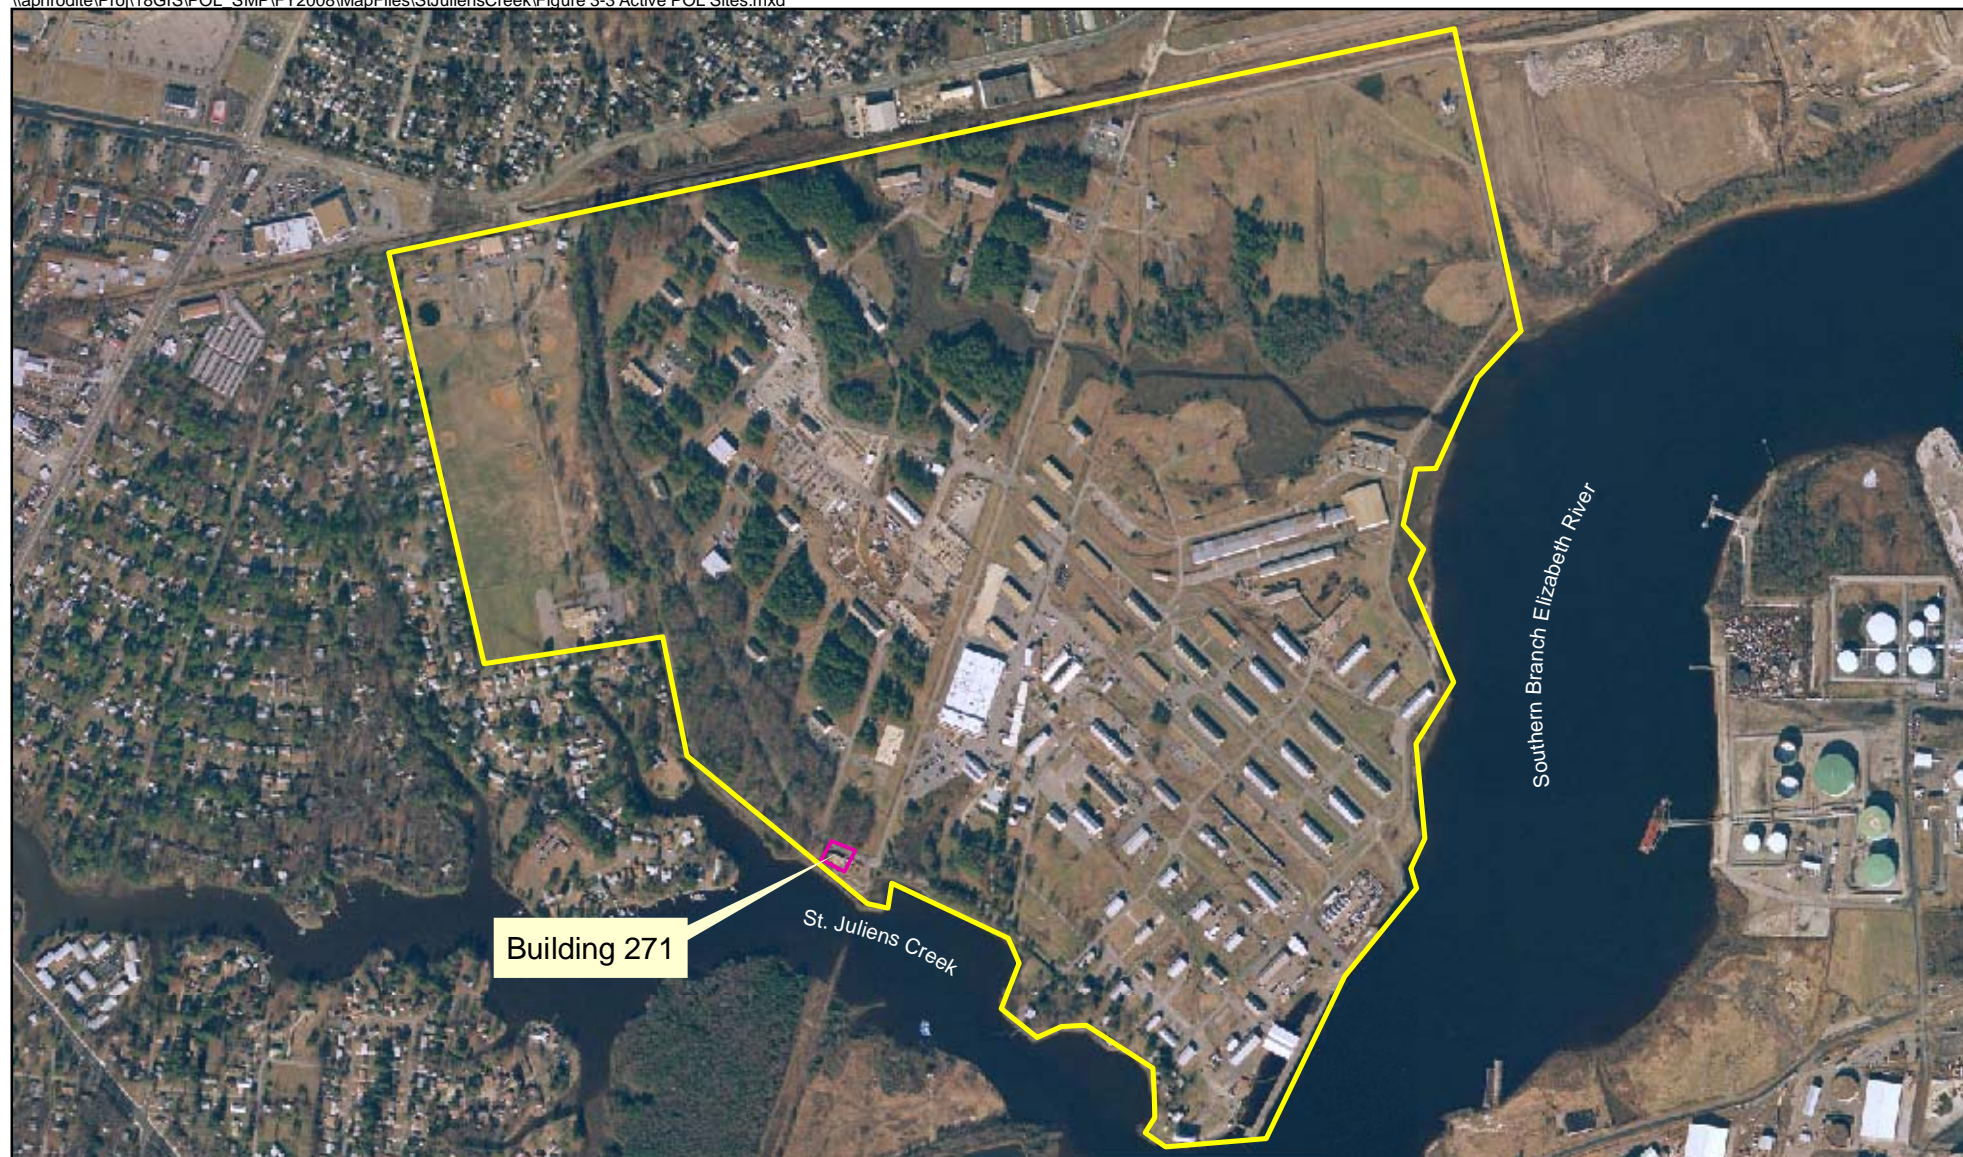
Figure 3-3  
Active POL Site  
St. Juliens Creek Annex  
Chesapeake, Virginia

- Active POL Site
- Activity boundary

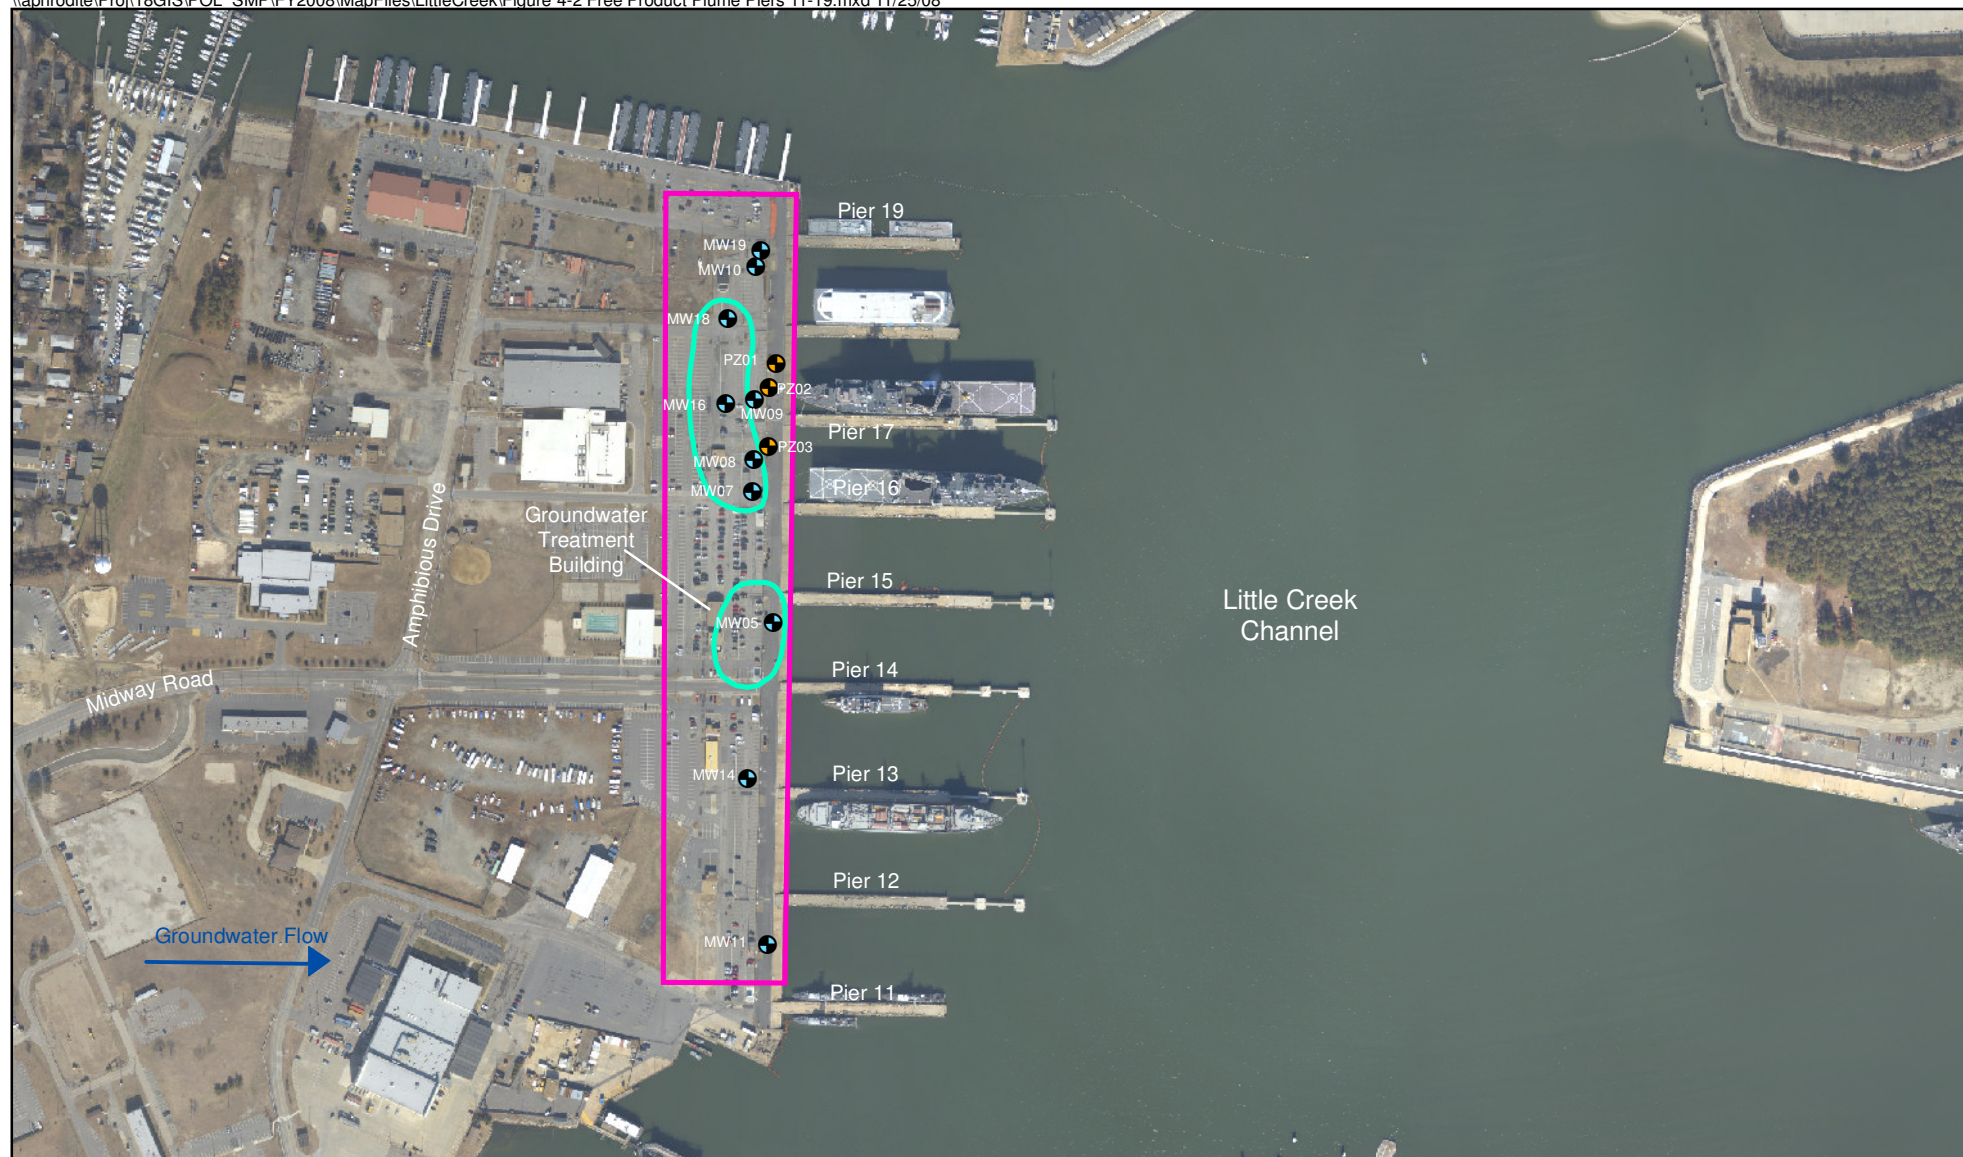
- Monitoring Well
- Piezometer
- Site Boundary
- Free Product Plume (March 2008)

The Piers 11-19 site is characterized by relatively permeable medium to coarse silty sand, with an average hydraulic conductivity value of  $6.63 \times 10^{-2} \text{ cm/s}$ , and shallow depth to water (7 to 8 ft bgs). LNAPL is considered residual in nature and additional recovery via skimming or AFVR is expected to be minimal. Spot excavation of residual impacts, particularly in the region of MW-05, MW-16, and MW-18 would be effective, but complicated by the high permeability sands and proximity to surface water (shoring would likely be required). Higher permeability favors biosparging or nitrate flushing in target areas. The estimated cost of nitrate flushing for 1 year is between \$40,000 and \$60,000.

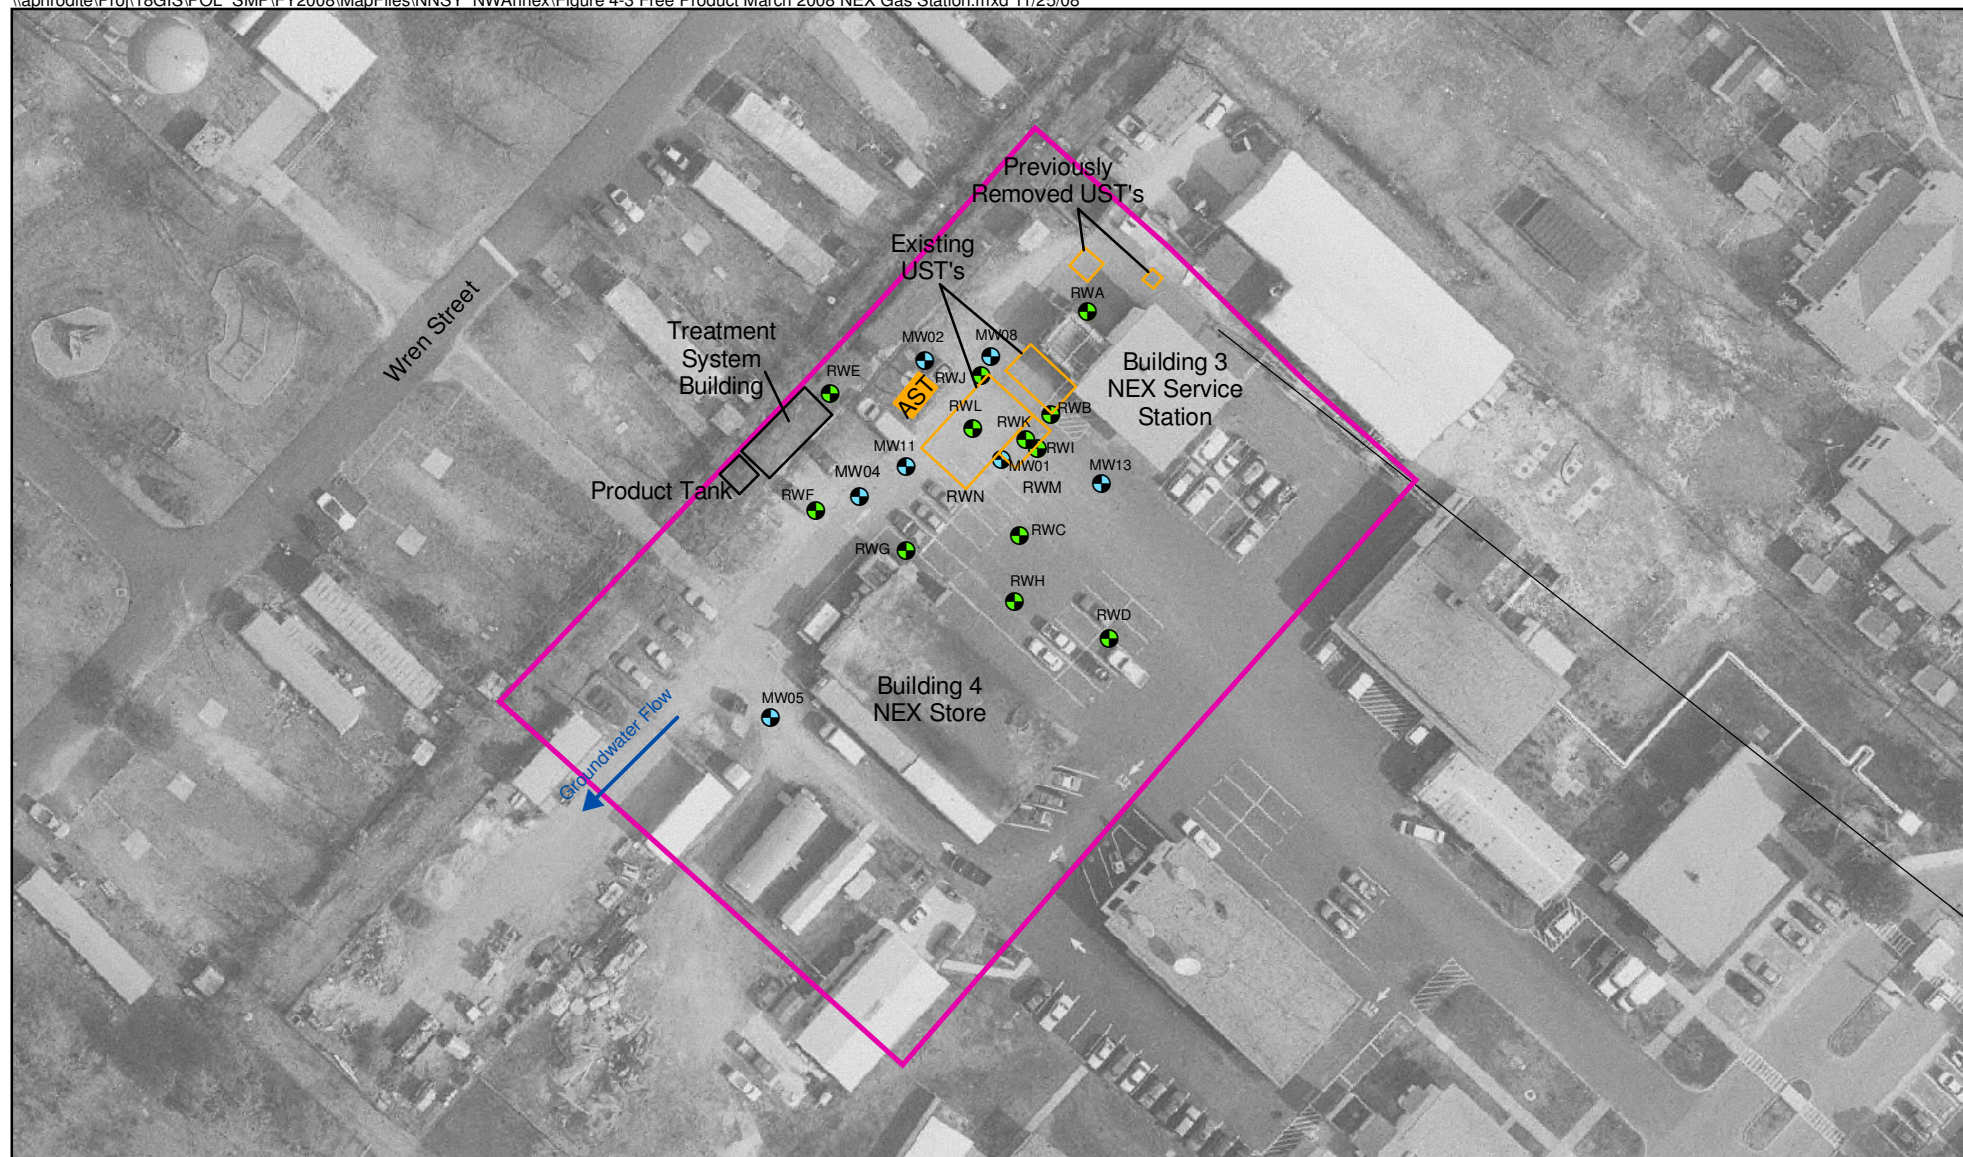
- Monitoring Well
- Recovery Well
- Site Boundary

The NEX Gas Station site is characterized by fine sand with some silt, with an average hydraulic conductivity value of  $1.27 \times 10^{-3}$  cm/s, and average depth to water of 3 to 7 ft bgs. Retrofitting the existing VE system (which was deactivated in January, 2004 because of low mass/vapor recovery and water table fluctuations) to perform biosparging or vacuum enhanced groundwater recovery should be considered. In either case, new wells would need to be installed, although existing conveyance piping could likely be re-used. The estimated capital cost of retrofitting the existing system is between \$75,000 and \$100,000.

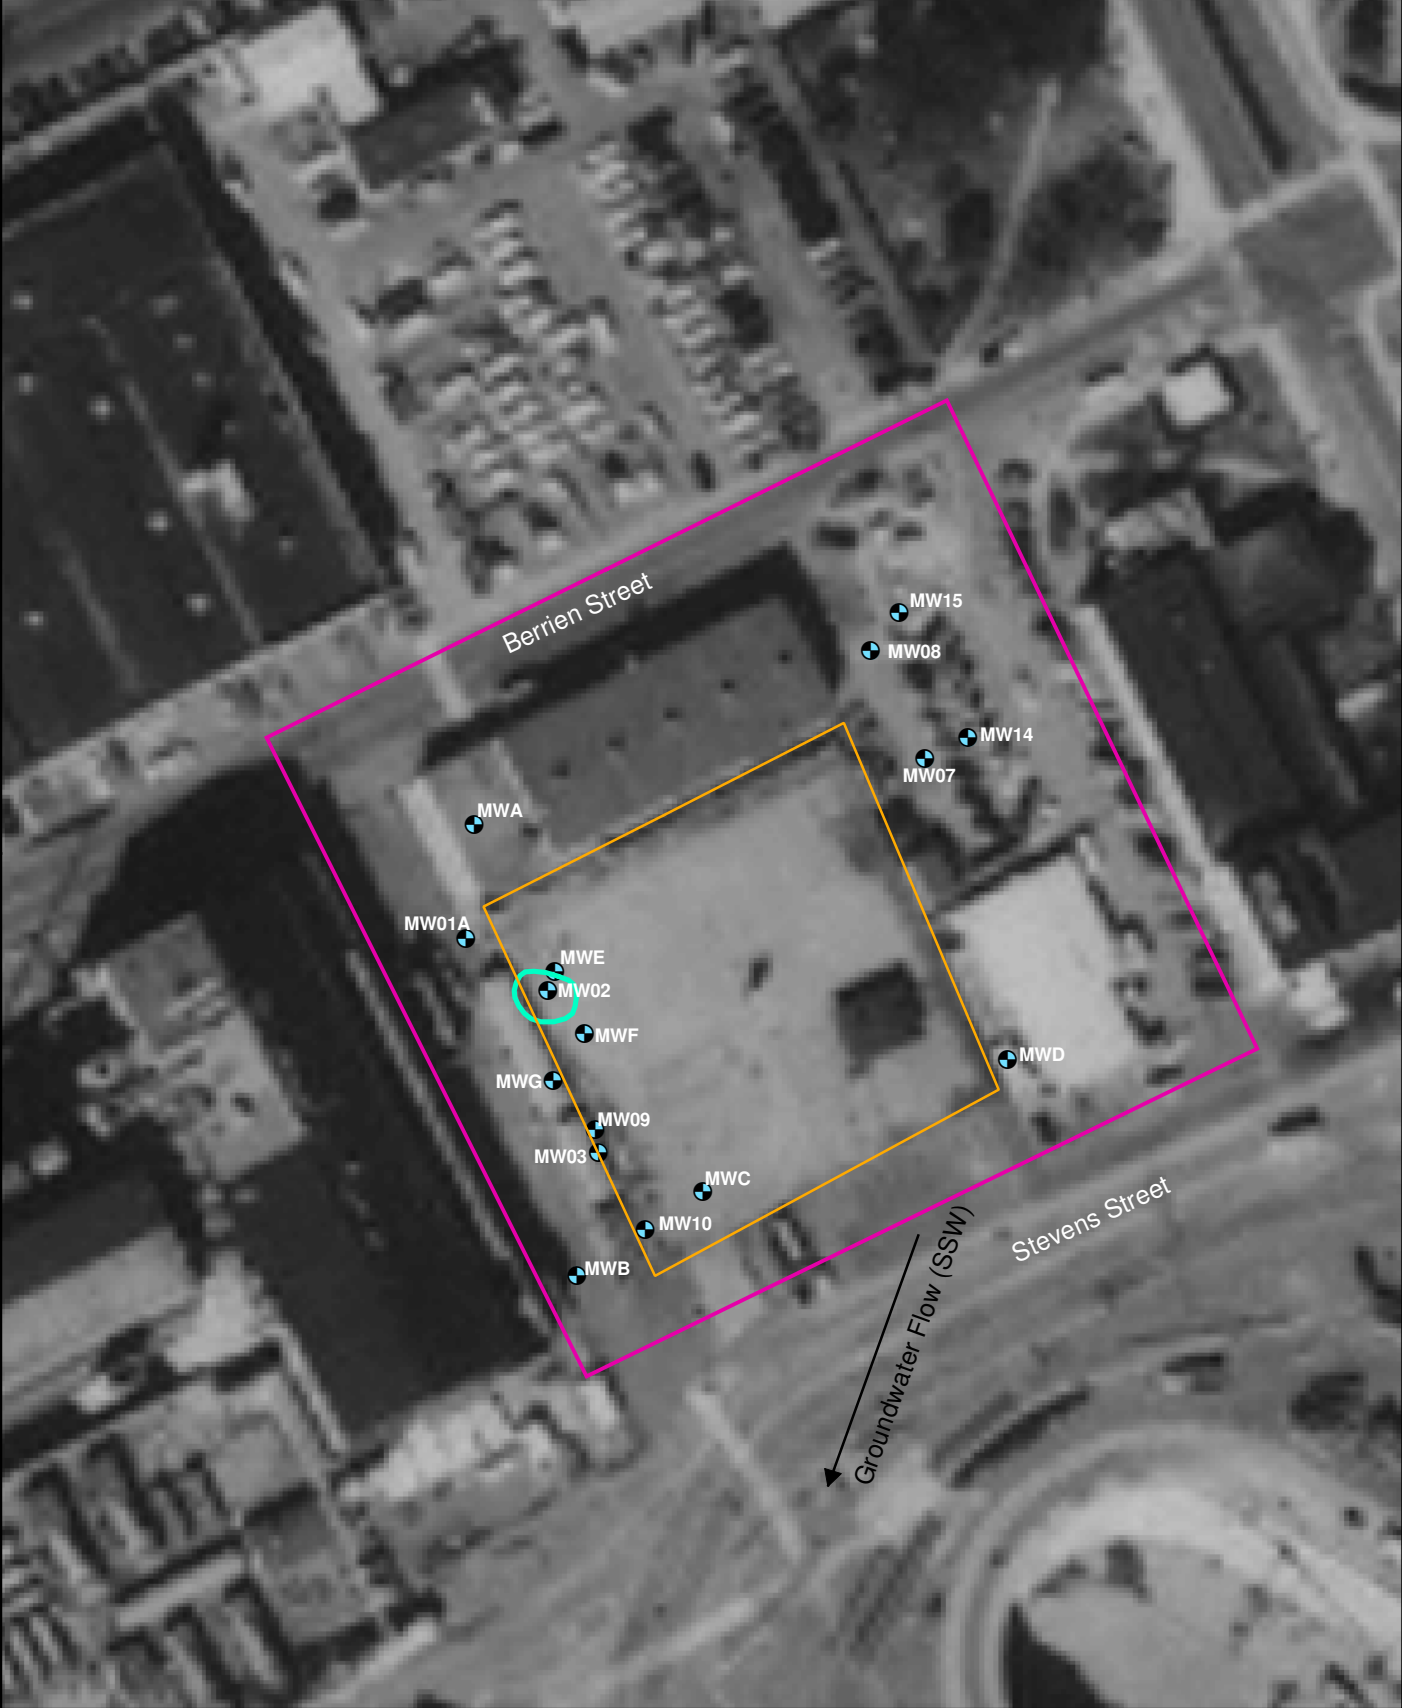
- Monitoring Well
- Tank 402 Boundary
- Free Product Plume (March 2008)
- Site Boundary

The Building 174 site is characterized by silt and sandy silt of unknown hydraulic conductivity (based on soil descriptions, hydraulic conductivity is inferred to be in low  $10^{-4}$  cm/s range). According to the SCR, the monitoring wells purge to completely dry quickly, and are slow to recover. The average depth to water is 4 to 8 ft bgs. LNAPL at the site (No. 6 fuel oil) is considered primarily residual; however, in some cases, seeps into the floor of Tank 402 have

been noted. Because of the unique logistical issues at the site, combined with the relatively low permeability subsurface and high viscosity product, options are limited. In the near term, AFVR events should continue to determine if the present trend of decreasing product thickness in MW-02 (the only well presently containing free product) can be maintained.

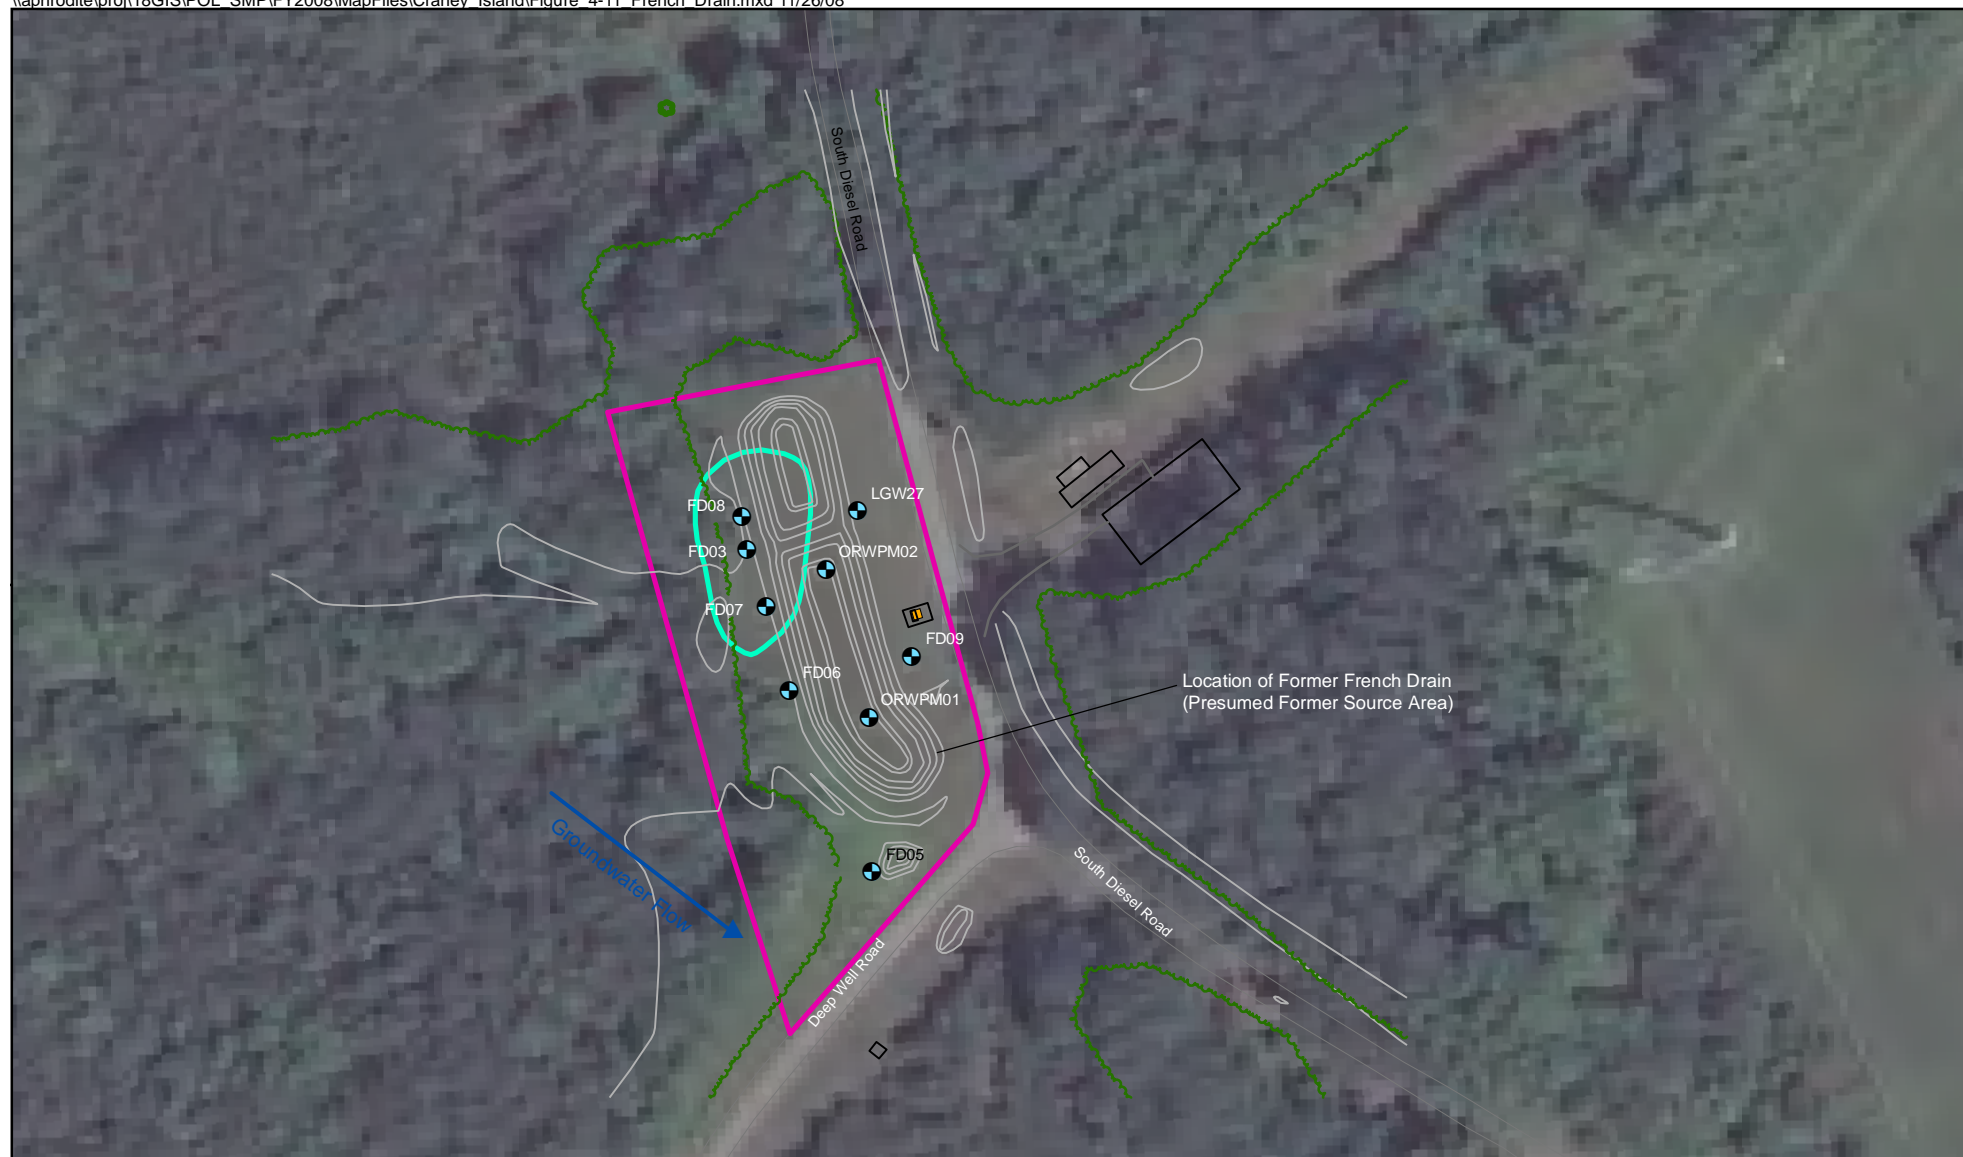
- Monitoring Well
- Free Product Plume (March 2008)
- Site Boundary
- Tank

Lithology at the French Drain site consists primarily of silty clay and clayey silt to the maximum explored depth of about 12 ft bgs, with some fine sand, particularly in the deeper portions of the soil column. The total estimated impacted volume of soil is approximately 180 cubic yards; however, the extent of contamination at the site is not well defined. Present recovery efforts include skimming and AFVR, with limited production during the first quarter of 2008 (13 gallons). A total of 1,346 gallons has been recovered from the site to date. There is only one well (FD-08) which contains a significant thickness of free product (> 1 ft). All other wells contain 0.3 ft or less of measurable LNAPL. Following additional delineation activities, excavation of target areas should be considered, because of limited remediation options in silty clays. The estimated cost of excavation in target areas is \$80,000.

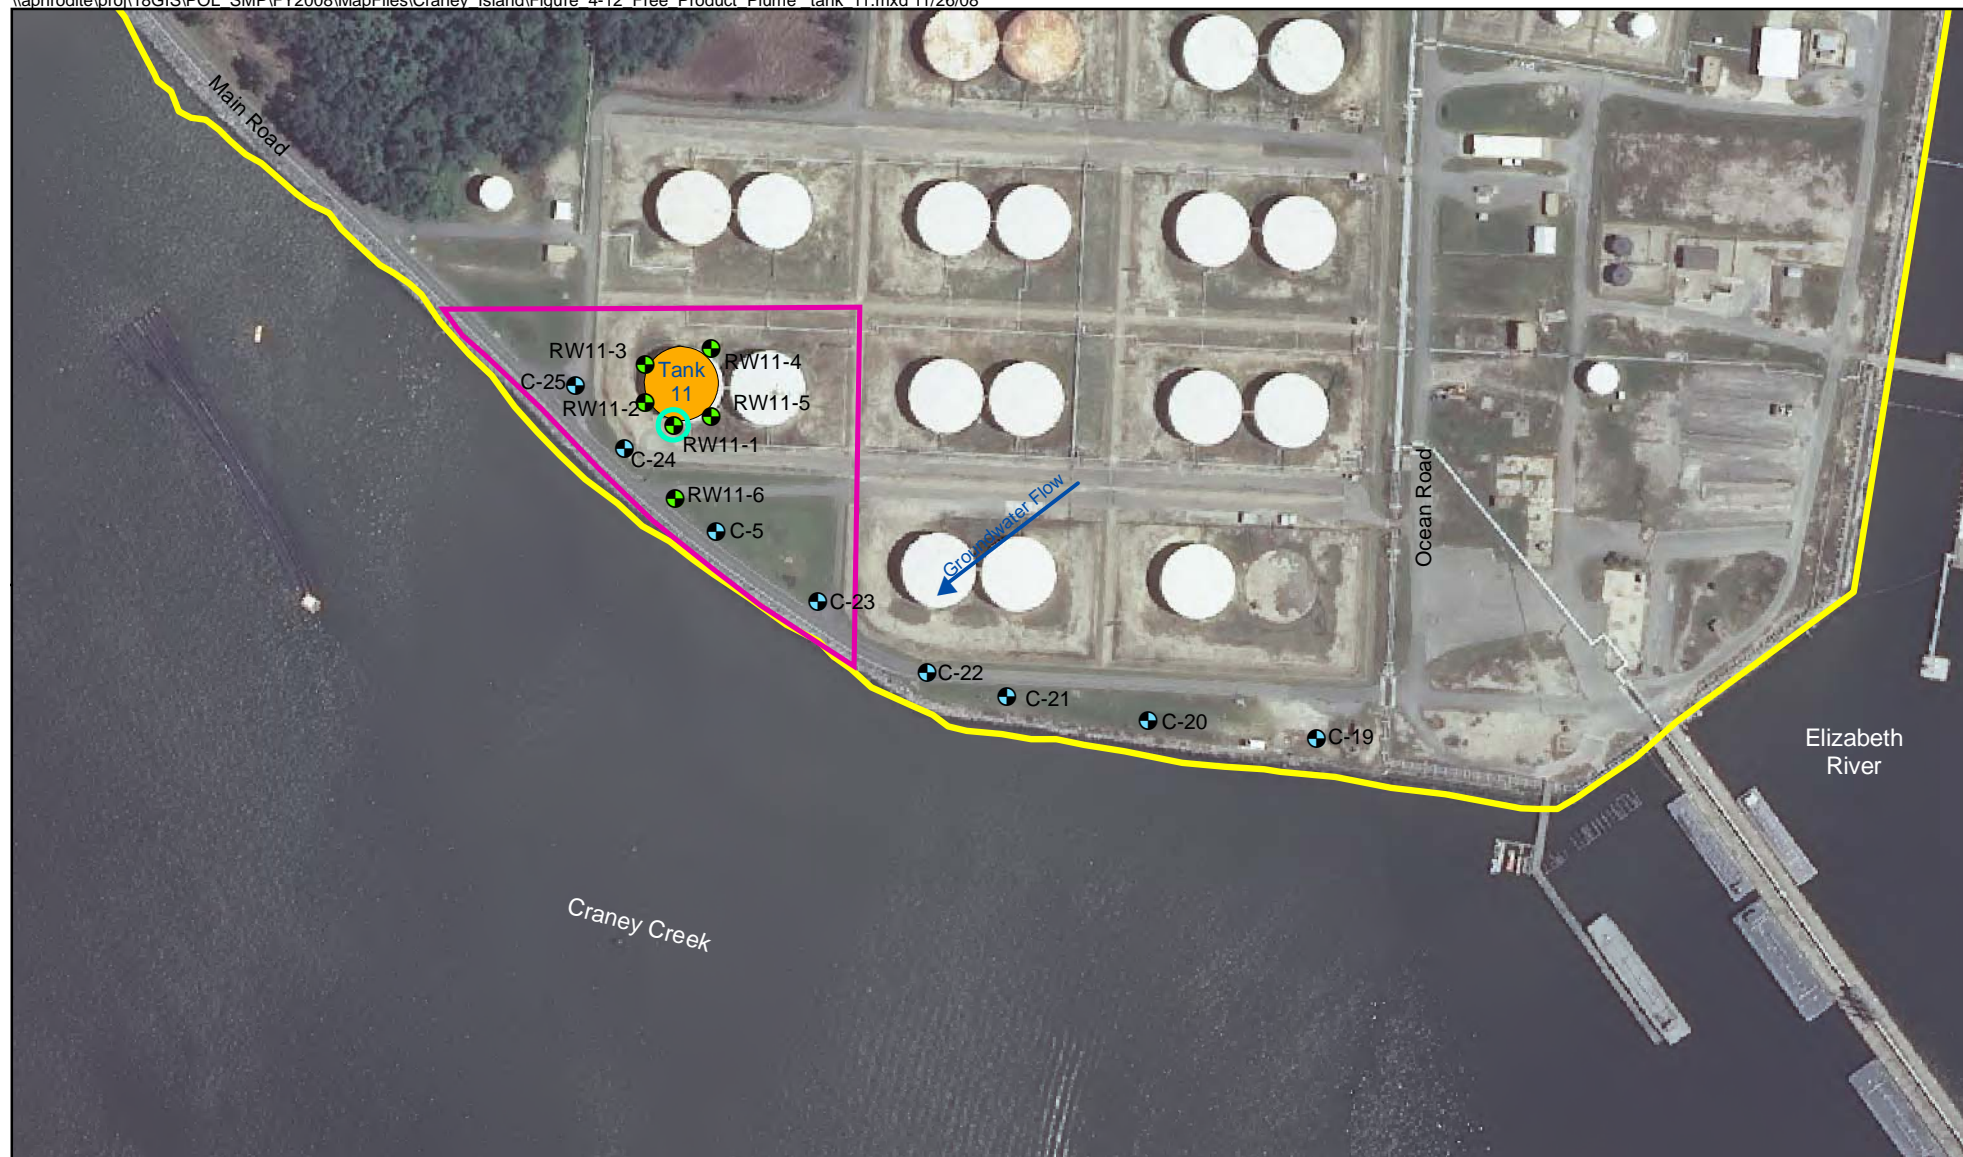
- Monitoring Well
- Recovery Well
- Free Product Plume (March 2008)
- Site Boundary
- Base Boundary

Lithology at Tank 11 consists primarily of a heterogeneous mixture of sand, silt, and clay, with a distinct clay layer noted in most of the boring logs just below grade. Present recovery efforts include AFVR events, with limited recovery from six recovery wells in the first quarter of 2008 (less than 10 gallons), and total cumulative recovery of approximately 200 gallons since January 2005. There is only one well (RW-11-1) containing measurable free product, of the 13 gauged. The thickness of LNAPL measured in RW-11-1 as of March 2008 was 0.02 feet. Because of the limited presence of residual LNAPL at this site, no additional action, aside from ongoing AFVR events, is recommended at this time. In the event that free product thickness does not decline, nitrate flushing or addition of an oxygen source such as ORC® may be effective in expediting site closure. Costs associated with nitrate flushing around one well for 1 year are estimated to be between \$15,000 and \$20,000. Alternatively, any contaminated soil could be excavated during tank removal.

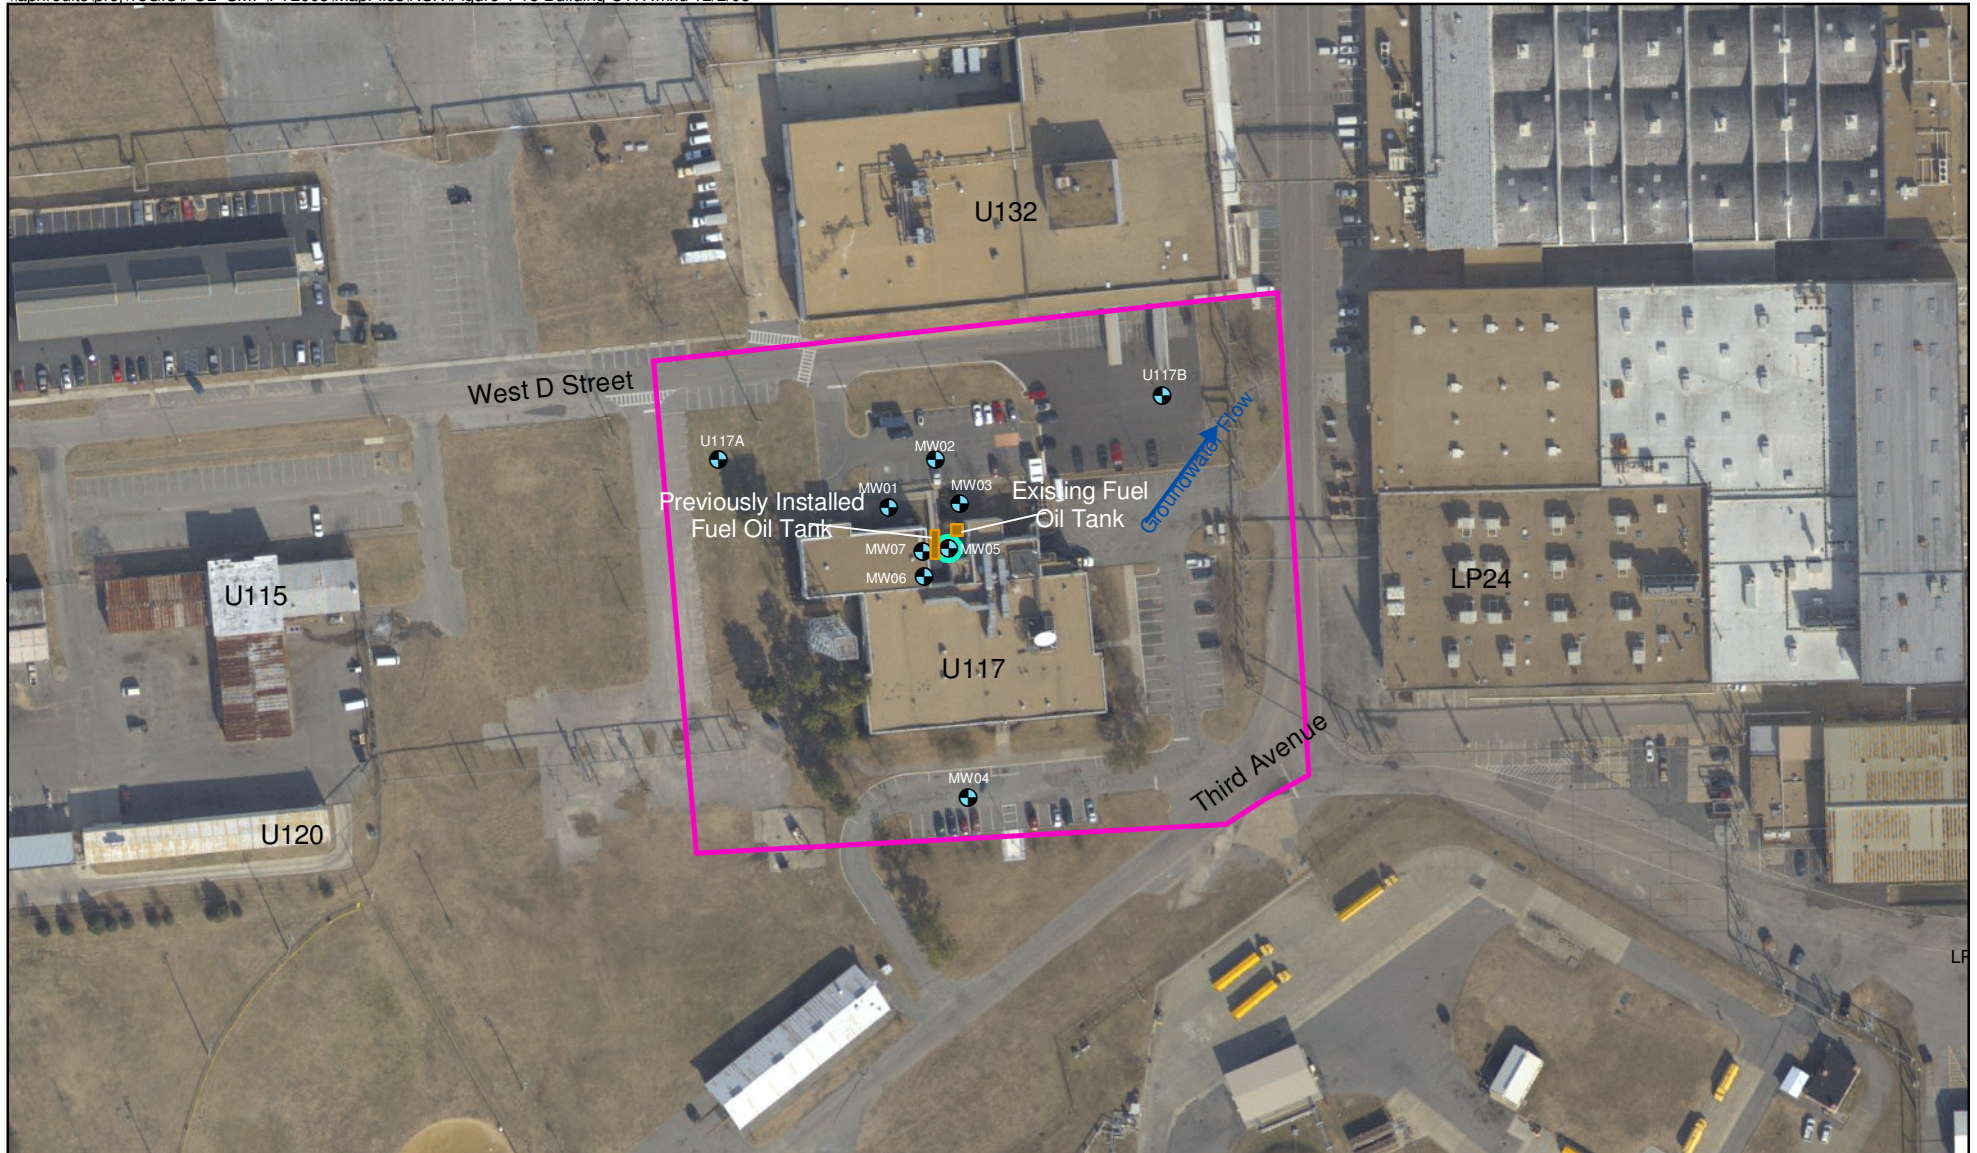
- Monitoring Well
- Free Product Plume (March 2008)
- Site Boundary

Lithology at the U117 site consists of interbedded sand, silt, and shells. Hydraulic conductivity at the site is approximately  $10^{-2}$  cm/s. Measurable free product has been detected in only one well (MW-05) during recent rounds of monitoring. During the first quarter of 2008, free product thickness was less than 0.05 ft, and during the March 2008 round of monitoring; only a sheen was detected. Additional monitoring will be continued to determine if the remedial endpoint of less than 0.01 ft of free product will be met for 6 consecutive months. If this goal is not met, addition of nitrate/nutrient amendments or an oxygen source such as ORC® is recommended to facilitate biodegradation since remaining contamination is residual and is not likely to be recovered using free product recovery methods. Costs associated with nitrate flushing around one well are between \$15,000 and \$20,000.

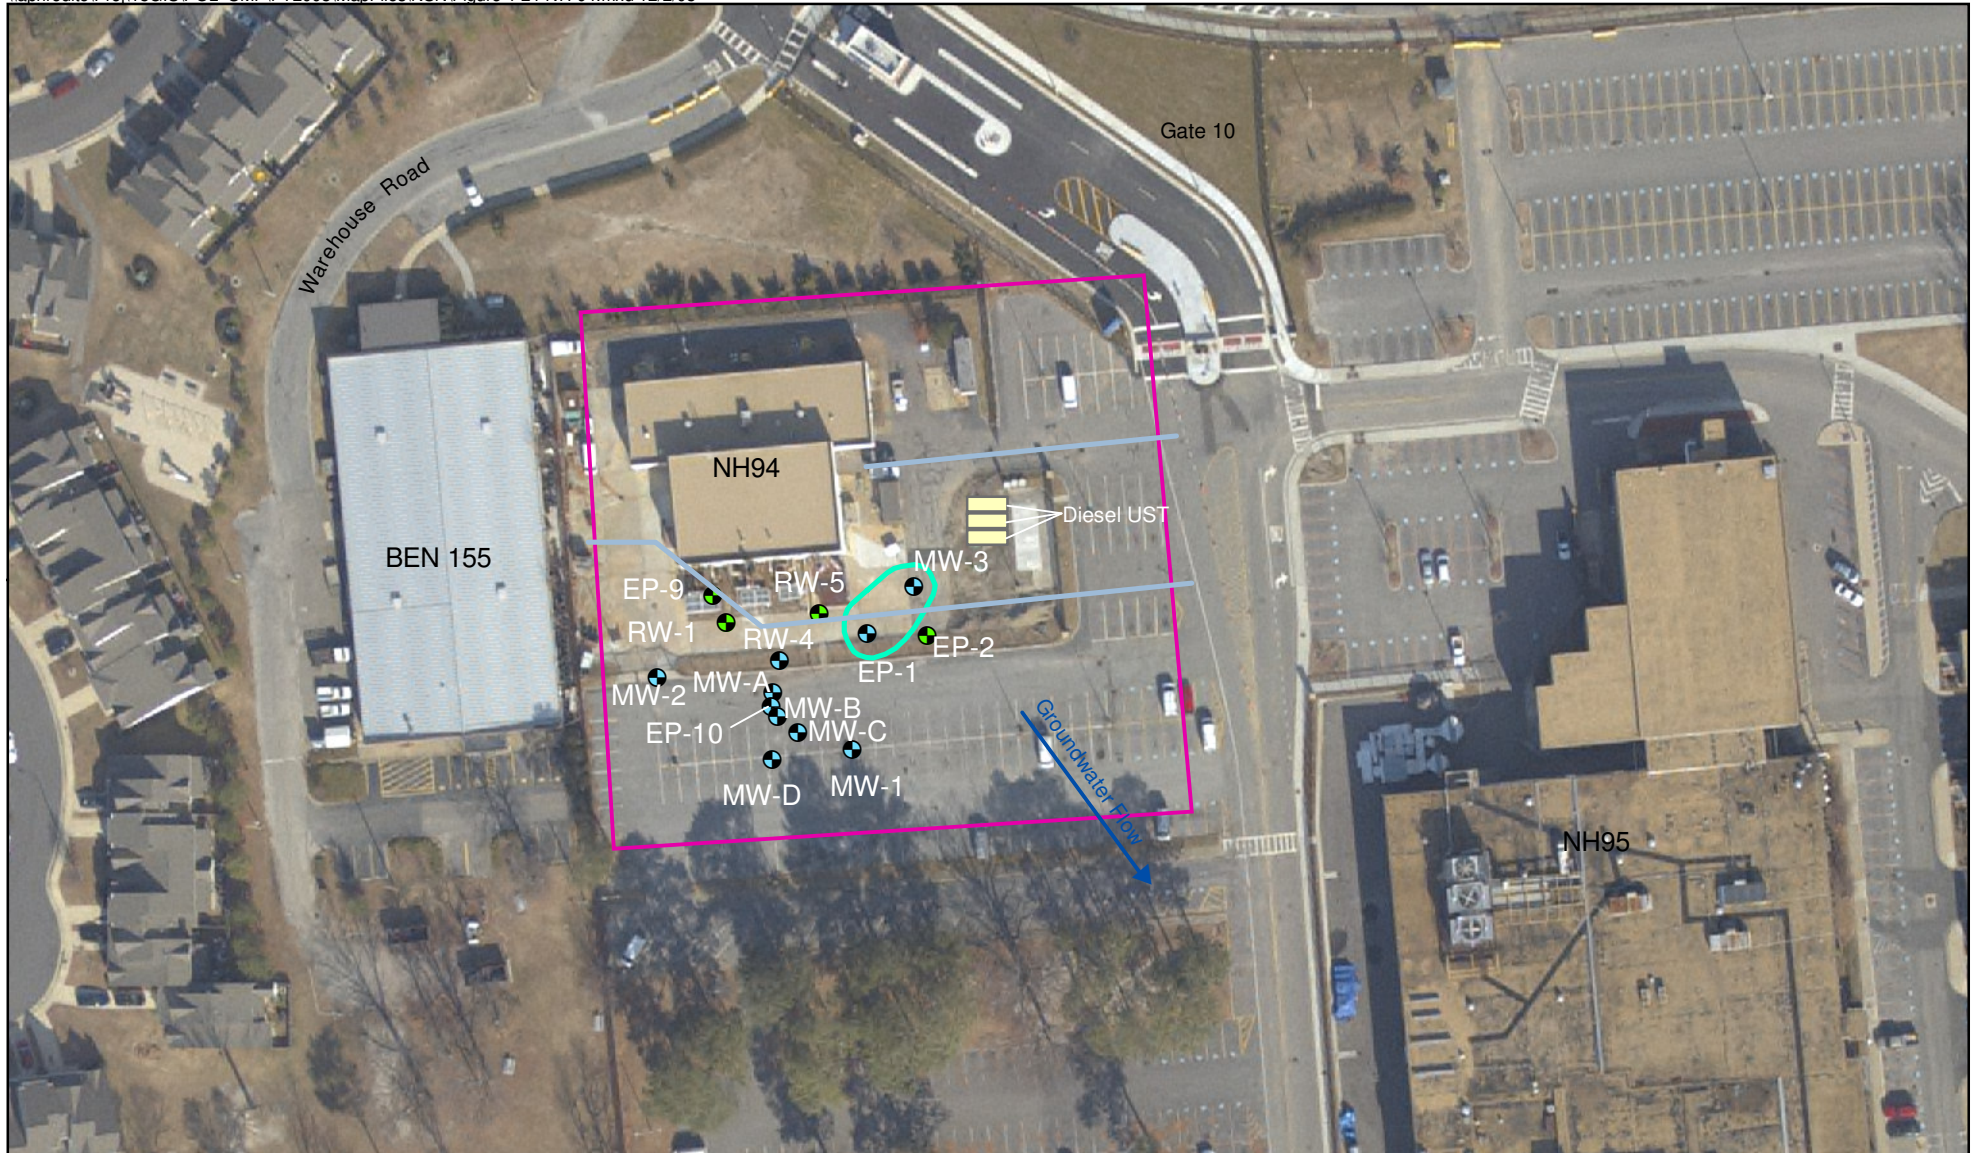
- Monitoring Well
- Recovery Well
- Free Product Plume (March 2008)
- Site Boundary
- Stormwater Line

Lithology at the NH-94 site consists of coarse sand with varying amounts of silt, clay and gravel. Hydraulic conductivity measurements have not been completed at the site, but based on the soil type, the hydraulic conductivity is estimated to be  $10^{-1}$  cm/s. Free product recovery is currently completed using vacuum recovery. Typically, less than 0.25 gallons of product are recovered during each event. Free product is present in two wells at thicknesses of 0.1 ft. The diesel product present is likely to be residual given the low recovery rates. The impacted zone is relatively small at the site (40 ft x 40 ft). Excavation may be an option; however, utilities may complicate this alternative. Periodic pumping of a nitrate/nutrient or amendment or oxygen source such as ORC® is recommended if excavation cannot be completed. Costs area estimated to be between \$15,000 and \$20,000.
